# Outcomes of Road Safety Audit of Yamuna Expressway

This study presents the outcomes of the road safety audit done on Yamuna Expressway (YE). YE is a high speed road connecting Greater Noida to Agra in the State of Uttar Pradesh, India. The first objective of the audit is to identify geometric design deficiencies in the YE alignment. Also to check the safety issues at the entry exit ramps, toll booths and road side facilities along the corridor. Second objective is to identify deficiencies in road signages, road marking and crash barriers on the YE corridor. Third objective is to identify high crash locations based on last six year road traffic crash (RTC) data along the corridor. Based on the observations of the audit measures have been suggested to improve road safety compliance along the corridor. Recommendation were based on the current codal provisions of IRC. And where Indian codal provisions are not available recommendations are based on international best practices.

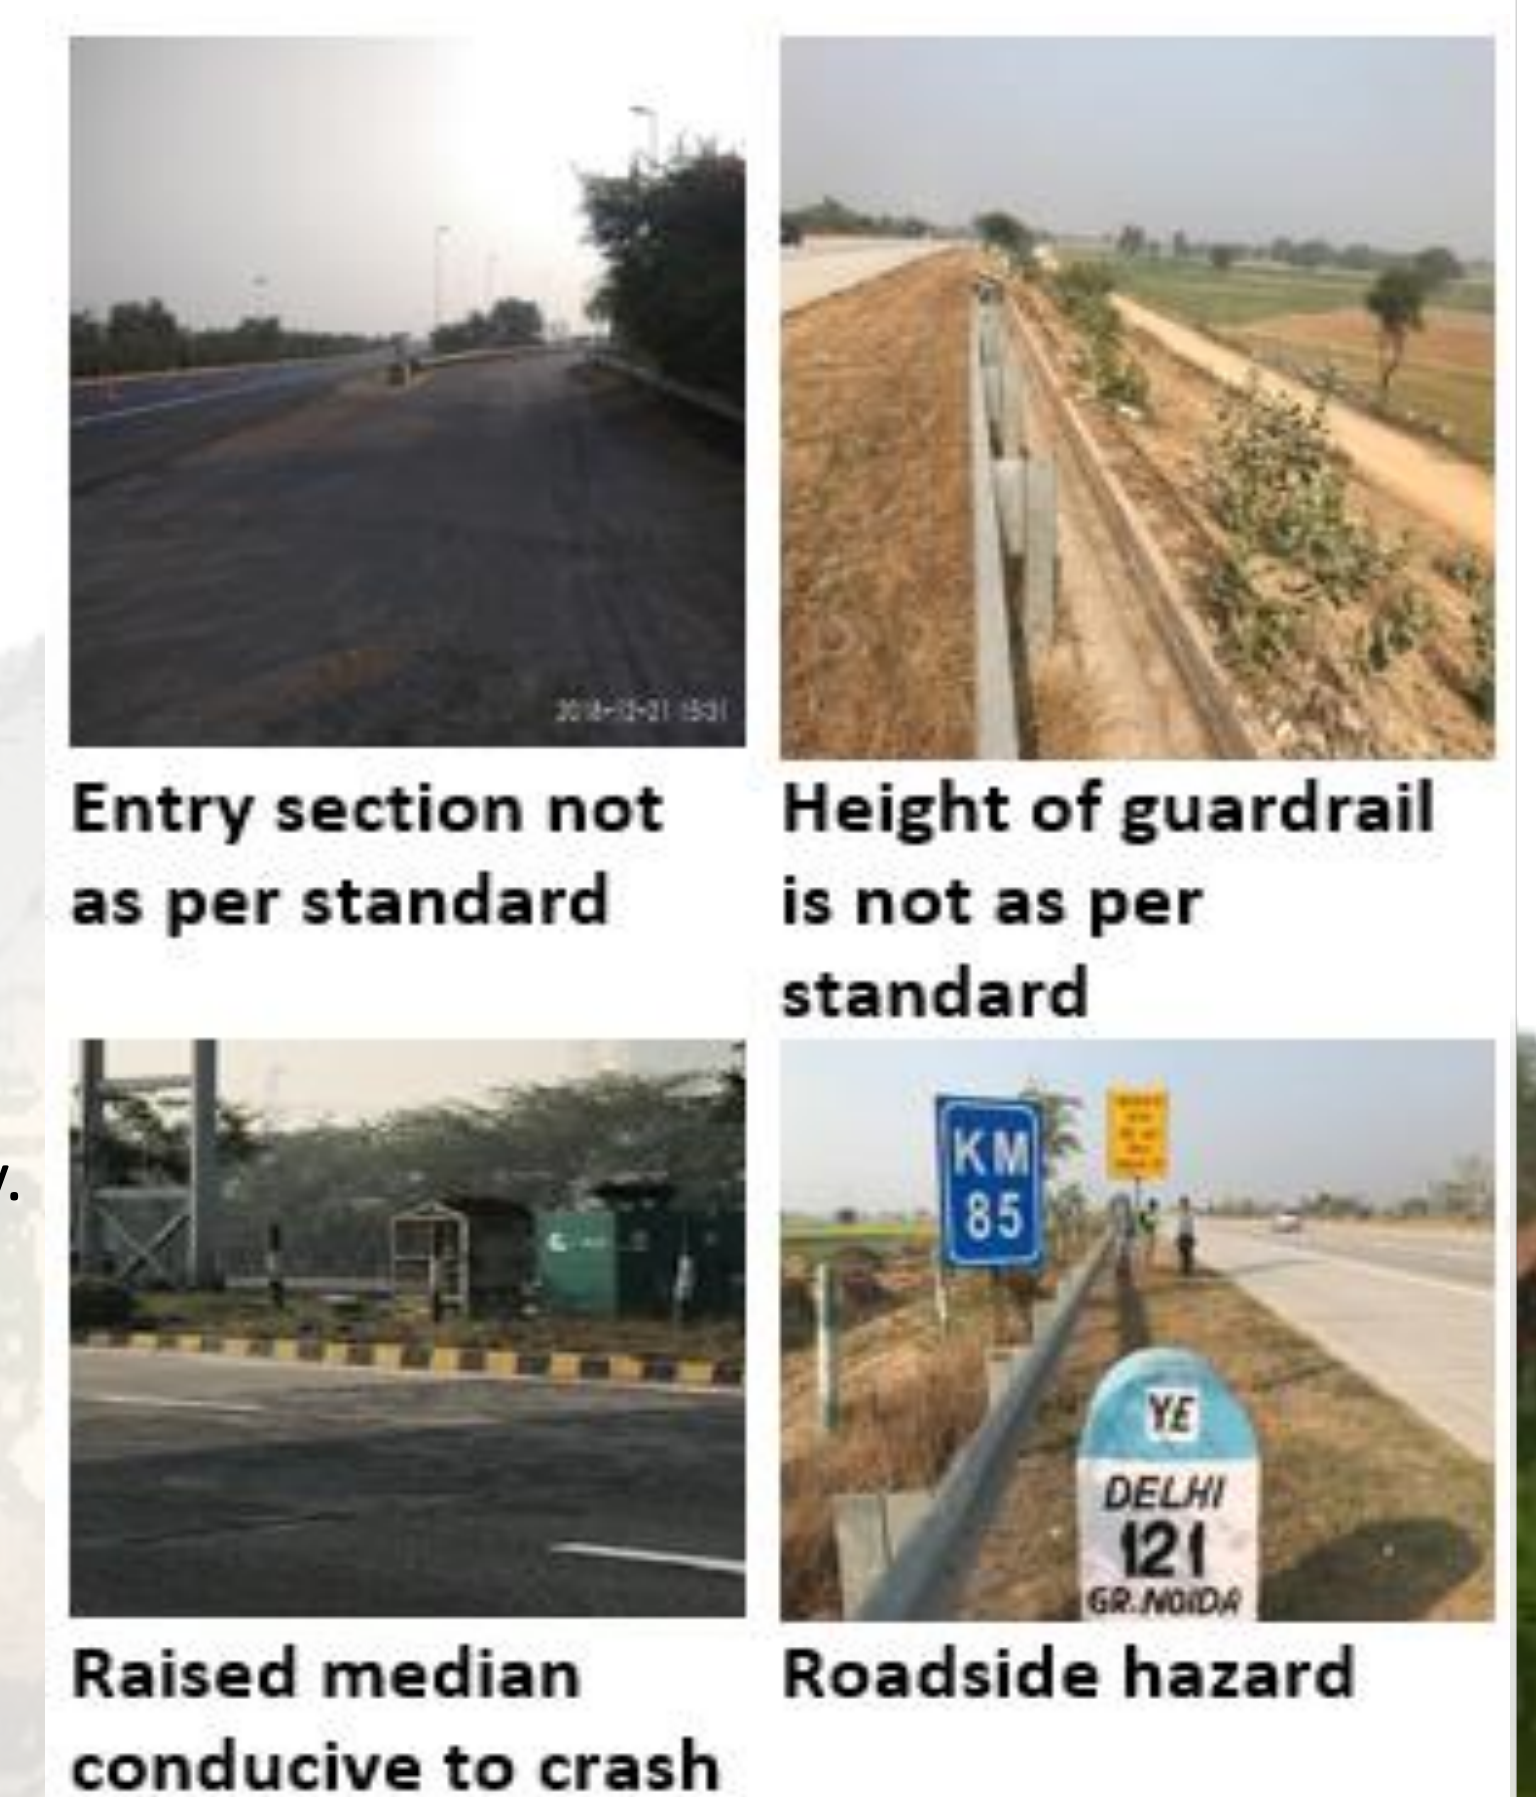
- Median is raised.
- Height of crash barrier is not as per standard.
- Crash barrier for the gantry poles present on the shoulder is incorrect.
- Damaged crash barrier is not replaced.
- Crash cushions are not as per standard.
- Chevron marking not as per standard.
- Directional markings are inadequate.
- Advance warning signs are missing.
- Transitions between steel w beam guardrail and concrete culvert is inappropriate.
- Hazards are present in clear zone.
- Pedestrians and 2W are using the expressway.
- Non-standard signages are present.
- Hard shoulder is marked as 2W lane.
- At entry and exit ramp location wrong side driving was observed.
- Acceleration and deceleration lane markings not as per standard.

- Review and modify the geometric design features of expressway.
- Change the existing raised median to flushed median.
- Shoulder rumble strips installed as per as per recommendations of FHWA T 5040.39 Revision 1.
- Enforcement implementation by police with support from the concessionaire.
- Speed control measures: Installment of additional speed cameras
- Installation of guardrail on median as well as on shoulder side as per IRC:SP:87-2013.
